Manhole Inspection Summary

Manhole # S35Y1_012MH

Location Address: **33 W. Talbot St.**

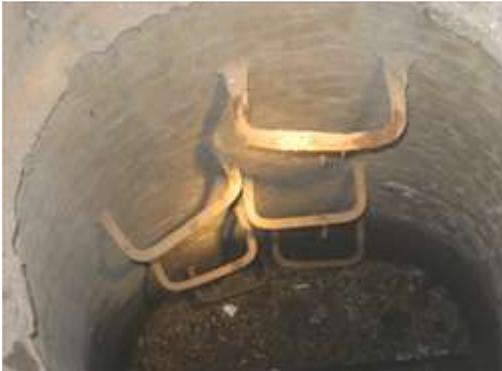
Steps Count: **6** Missing: **0** Corroded

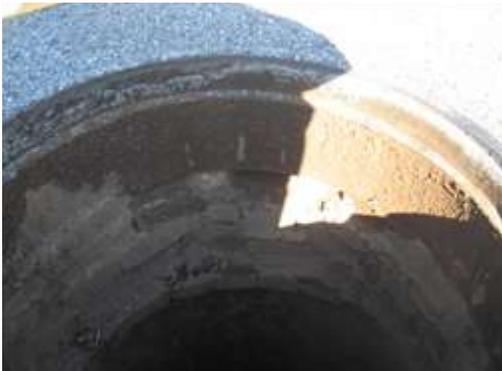
Defect 4

Infiltration: None Joint Cracks Mortar Roots **Wall**

Infiltration on Chimney

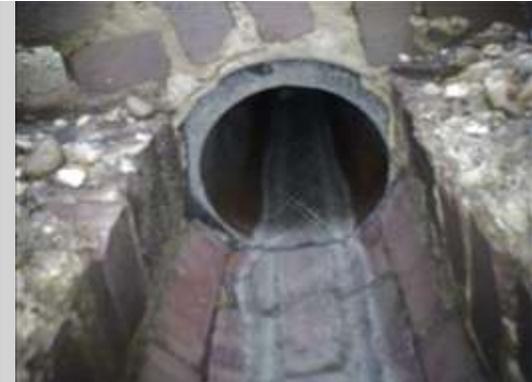
12 O'Clock Outflow

8 in. Circular Gravity Sewer
Pipe Out @ 12 O'Clock

Pipe Height: **12** (in.) Rod and Bar (Angled)
Pipe Material: **DIP/CI** Pipe Lined
Invert Depth: **12.24** (ft.) Flow Characteristics: **Slow**
Deposits: None Mud Sludge Debris Grease
Silt Depth: (in.) Deposits Extent:
Infiltration: **None** Pipe Seal Cond: **Sound**

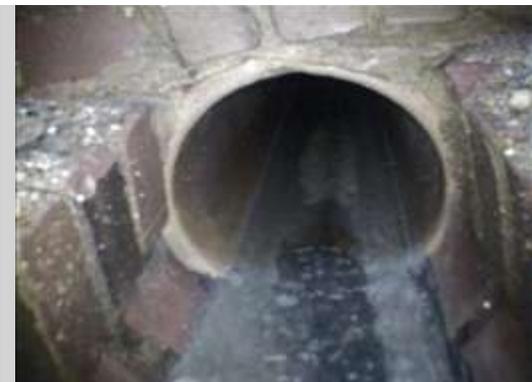
6 O'Clock Inflow

8 in. Circular Gravity Sewer
Drop In @ 6 O'Clock

Pipe Height: **10.8** (in.) Rod and Bar (Angled)
Pipe Material: **DIP/CI** Pipe Lined
Invert Depth: **12.00** (ft.) Flow Characteristics: **Fast**
Deposits: None Mud Sludge Debris Grease
Silt Depth: (in.) Deposits Extent:
Infiltration: **None** Pipe Seal Cond: **Sound**
